National Register of Historic Places Registration Form

Joorly. Ose typewiter, word processes of company to the pr		
1. Name of Property		<u>. </u>
historic name Dodger Point Fire Lookout		
other name/site number

Dodge	r Point	Fire	Lookout
	of Prop

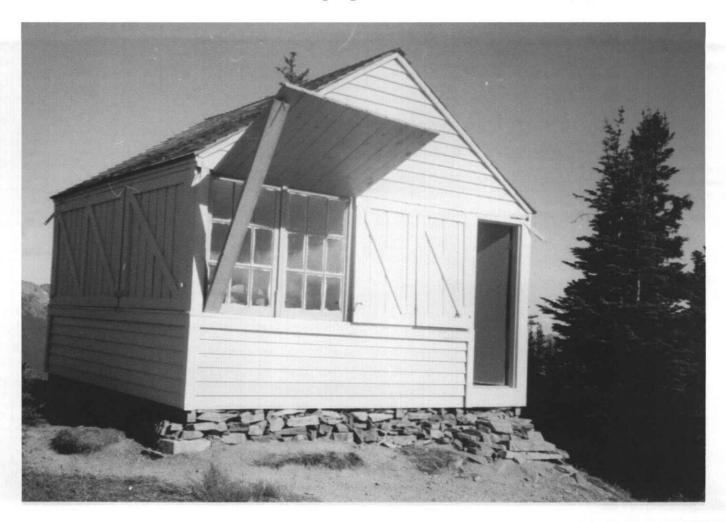
Description
Dodger Point Lookout; Other
Clallam County, WA; Elwha
view looking East
